**IMPACT RESISTANCE OF
COMPOSITE FAN BLADES**

**PRATT & WHITNEY AIRCRAFT
DIVISION OF UNITED AIRCRAFT CORPORATION**

NATIONAL AERONAUTICS AND SPACE ADMINISTRATION

CONTRACT NAS3-16763

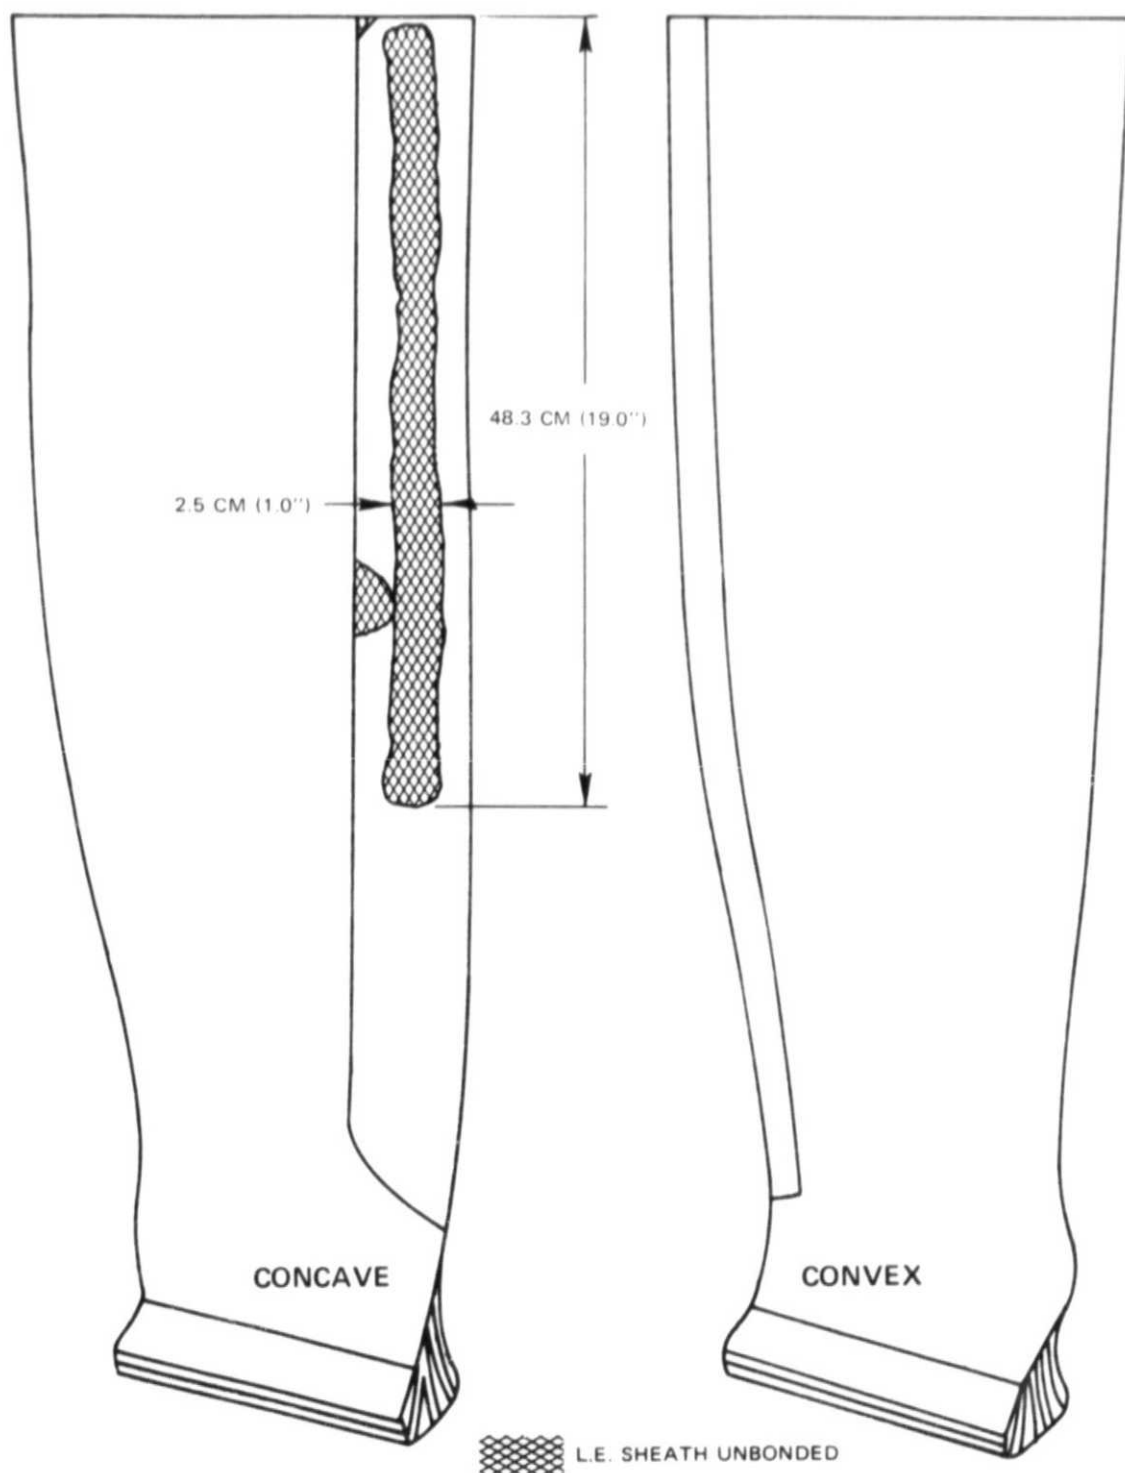
Figure 47 Visual Damage to Boron/Epoxy Blade B-4 Following Impact with Gravel

The gravel impact results on blade B-4 are shown in Figures 47 and 48. No ultrasonic indications were found after testing. Damage at the leading edge is negligible, even though the high-speed movies show that impacts did occur at this location. However, the concave side sheath, aft of the leading edge, was nicked, gouged, and unbounded, as pictured in Figure 49. The gravel apparently strikes the sheath causing compressive stresses on the sheath exterior surface. The stress differential within the sheath is great enough to break the sheath-to-blade bond and then lift the sheath from the surface of the blade. Therefore it is concluded that with a better bond between sheath and blade, the leading edge sheath could offer satisfactory protection from small amounts of gravel ingestion.

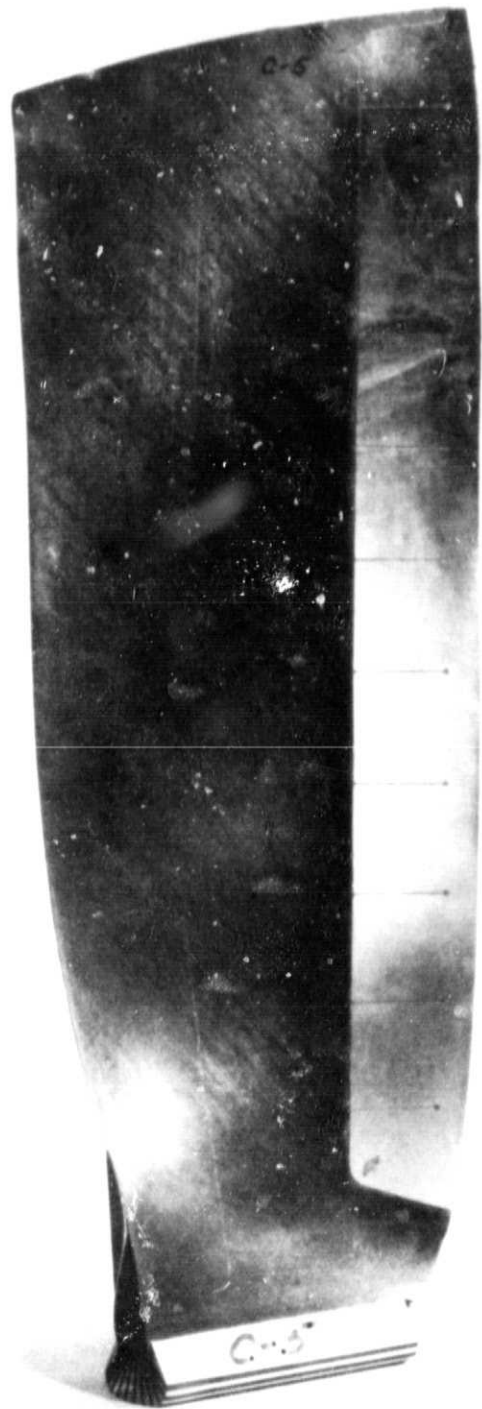
Figure 50 Graphite/Epoxy Blade C-5 Following Impact with 75g Starling

Blade C-5 and B-5 were impacted with 75g (2.6 oz) and 80 g (2.9 oz) starlings, respectively. The 40g (1.4 oz) slice taken by C-5 and the 45g (1.6 oz) slice cut by B-5 caused only slight damage in each case. The damage which occurred seems to be related to blade fabrication problems. Both blades are pictured in Figures 50 and 51 respectively.

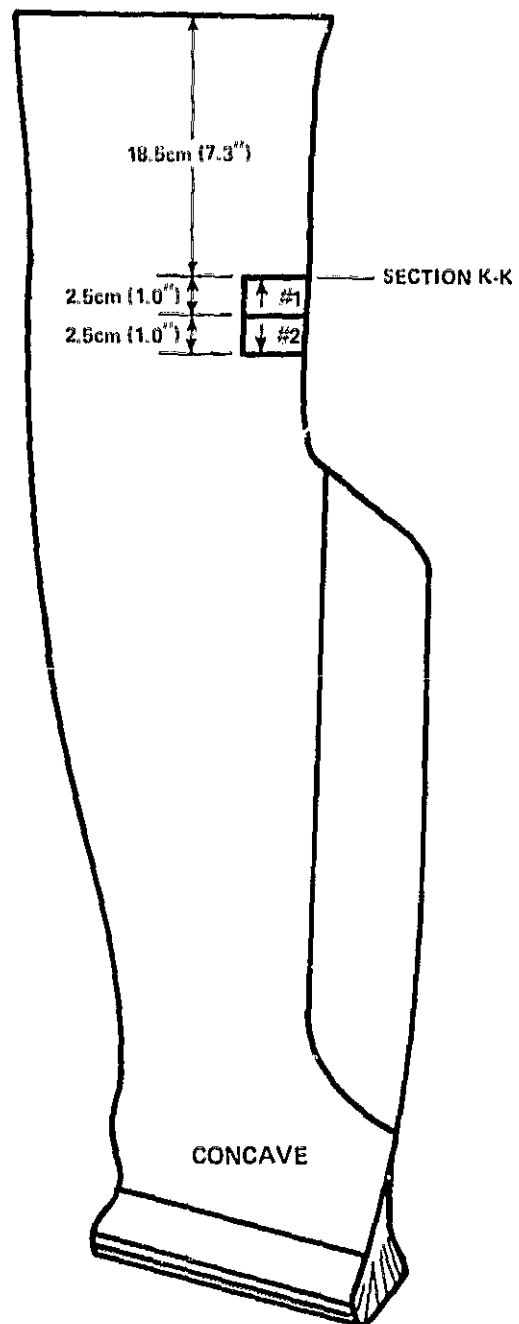
Figure 54 Metallographic Section Locations - Graphite/Epoxy Blade C-3

Graphite/epoxy blade C-3 was sectioned in the area of the impact damage for metallographic study. Two chordwise sections were examined, as illustrated in Figure 54. Section 1 revealed a shear crack of approximately .41 cm (.16 in) length angled at 40° from the concave blade surface as shown in Figure 55. Section 2, pictured in Figure 56, revealed five interlaminar separations which propagated for a length of .10 cm (.04 in) to .66 cm (.26 in) in the chordwise direction. No internal composite damage was found further away from the broken area of the blade.
